KOOTENAI DEVELOPMENT IMPOUNDMENT DAM

JULY 2011 ROUTINE OWNERS INSPECTION

Prepared for: The Remedium Group

Inspection Date: July 29th, 2011
Report Date: December 28th, 2011

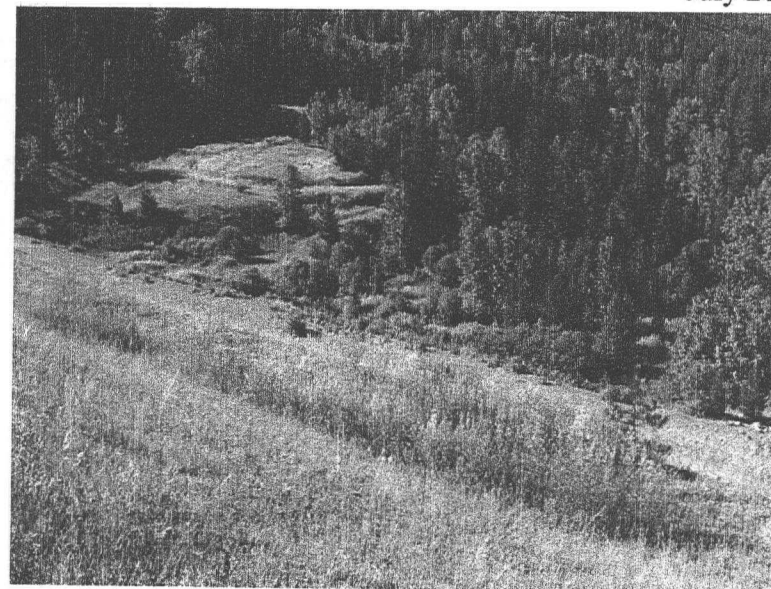
Downstream Slope of Embankment

7. No bulges, erosion or other anomalies and/or changes were noted to the embankment from the upstream face to the toe.
8. The spillway was not running but water was up to the entrance of the Box Culvert. Jeremy stated it was still flowing yesterday (approximately 10:00 a.m. July 28th) so it appears to have stopped sometime between yesterday and today. The spillway was observed by Chapman Construction to have been flowing since April 11, 2011. Flows this spring have resulted in a black sediment deposits in the open concrete spillway channel that was not previously observed.

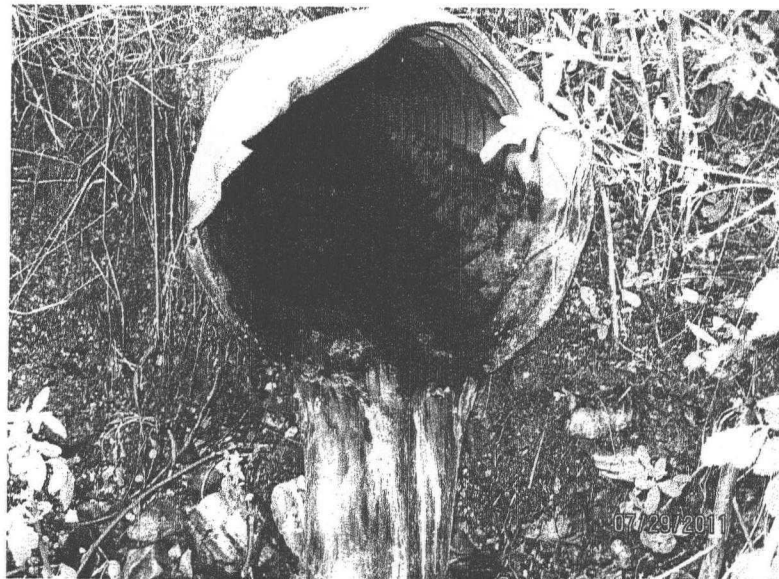
9. Drains were inspected and the flows in the drains and stream channel below the drains were measured and recorded. Drain flows are receding in response to lower inflows. Drain 1 is still running but notably lower. Seepage is still visible along the toe from drain 7 to drain 9 but is decreasing. Water is still flowing in drain 2 with no detectable change in the rate of flow. Standing water was not noted on the surface during this inspection. Drain flows were all recorded as clear and steady.

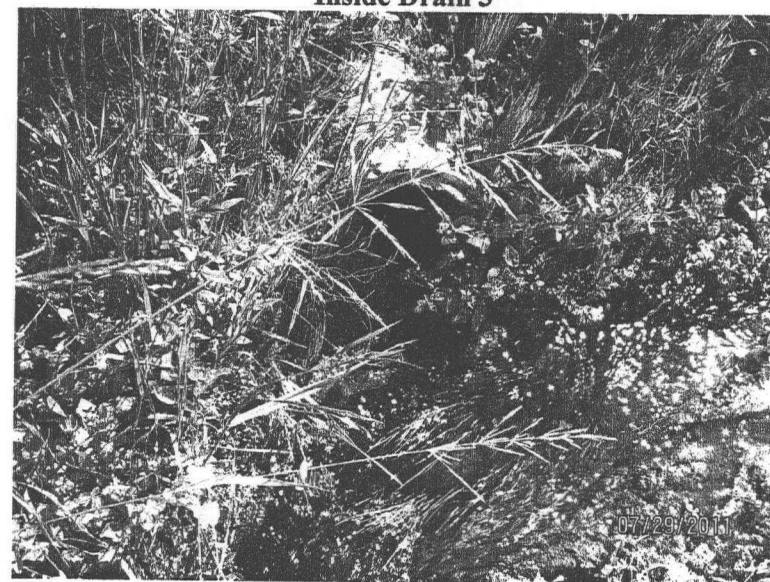
Drain 3

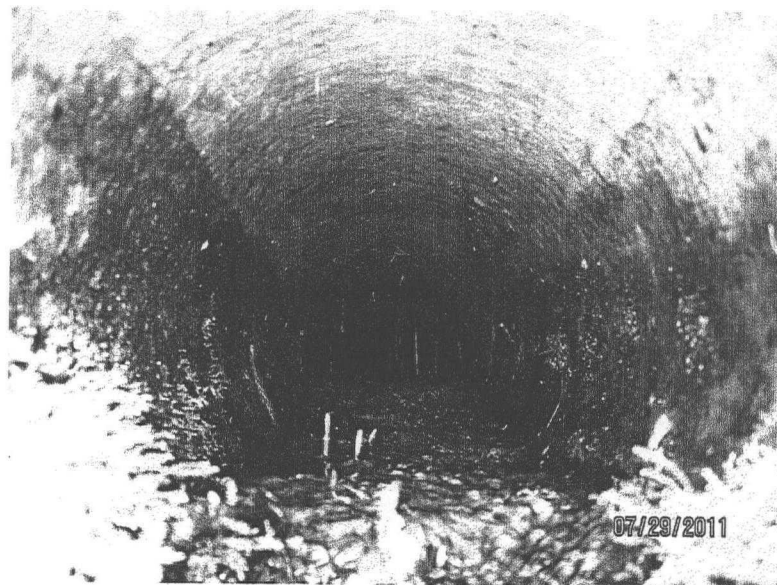
Drain 4

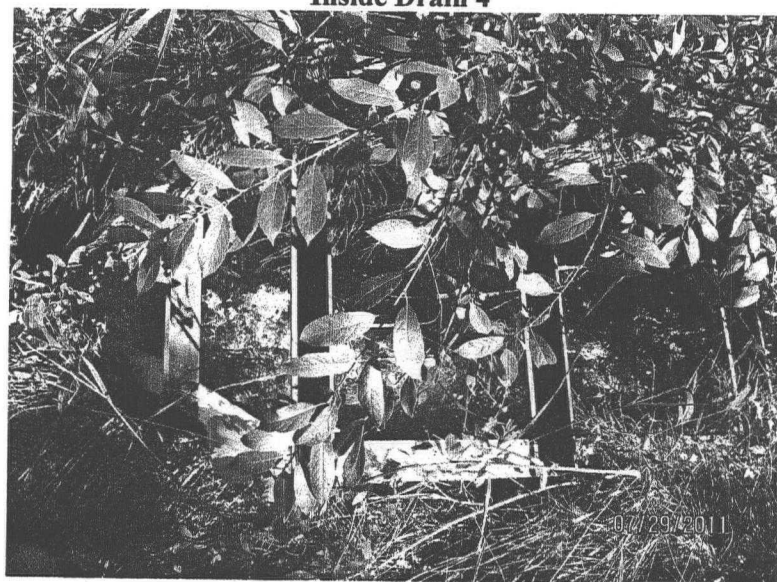
Flume 1-4 Gauge Height

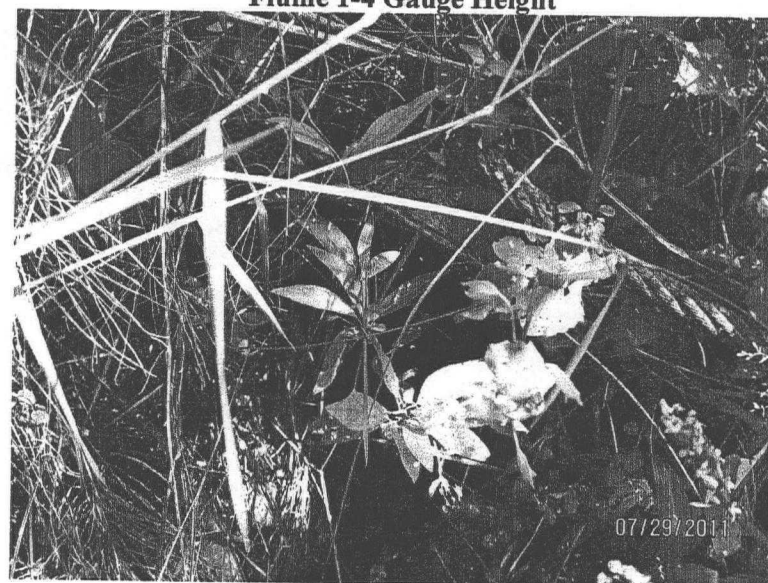
Flume 1-4

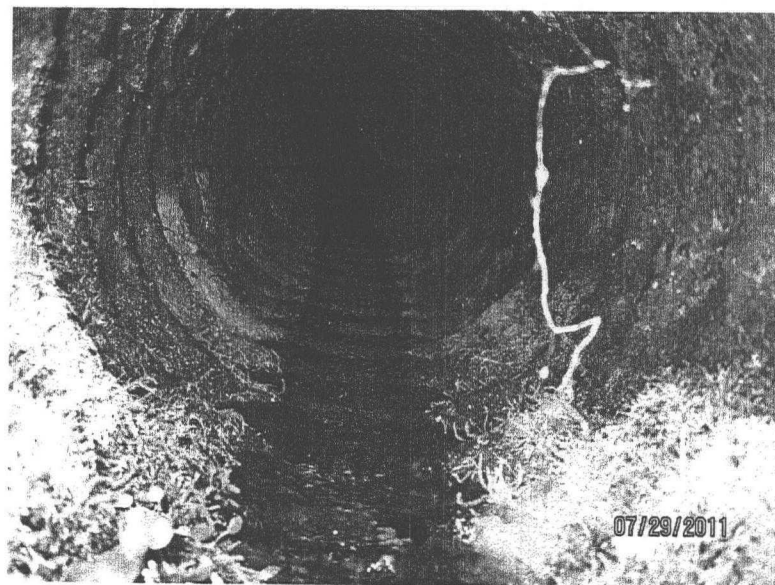
Drain 8

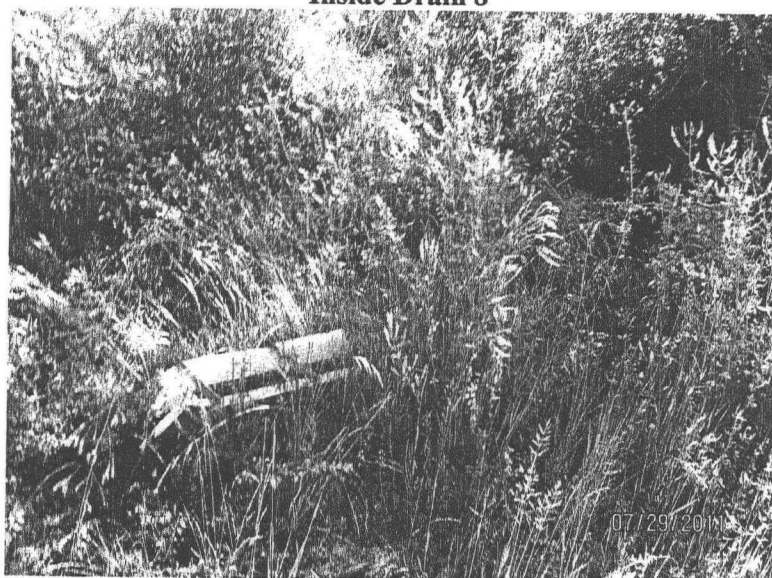
Flume 7-8 Gauge Height

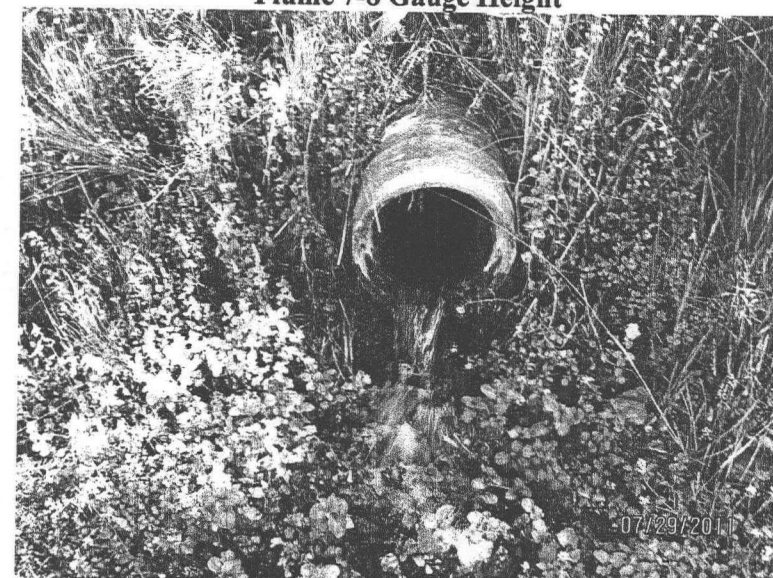
Flume 7-8

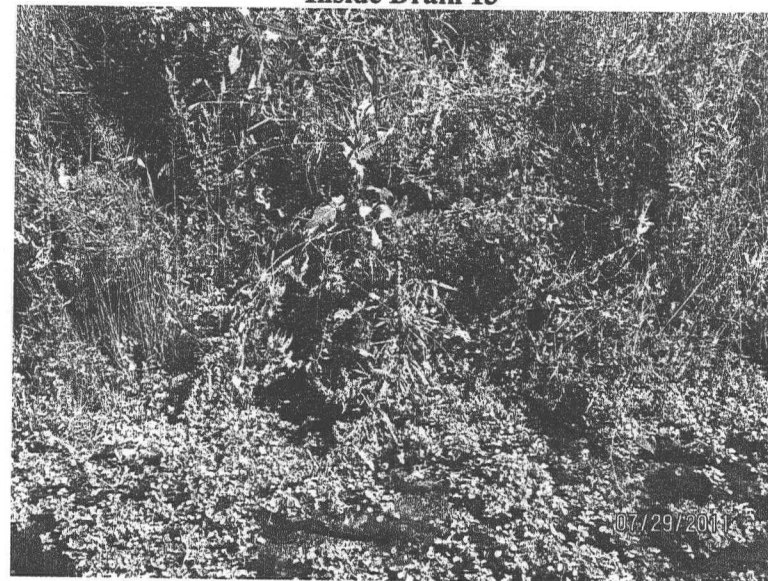
Drain 13

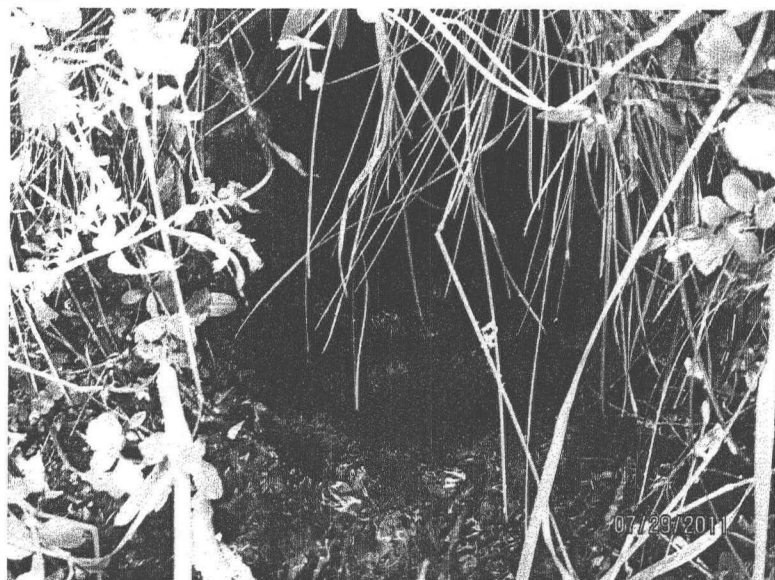
Drains 10 and 11

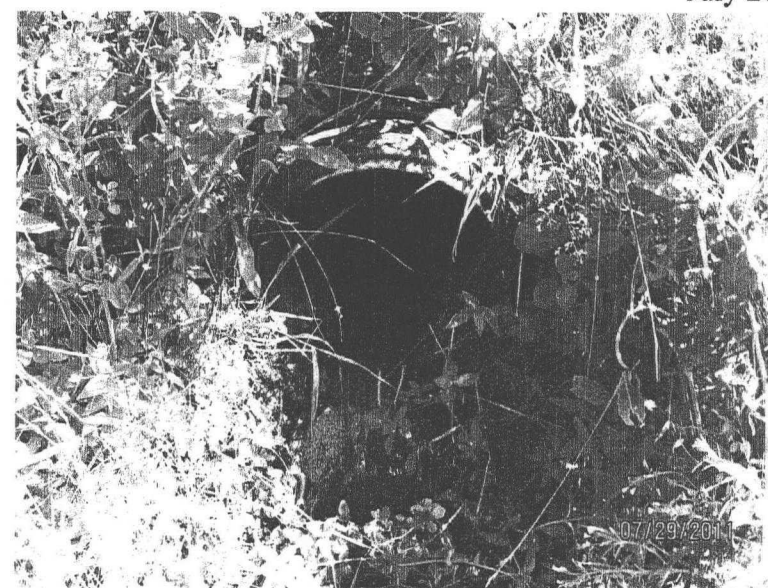
Drain 10

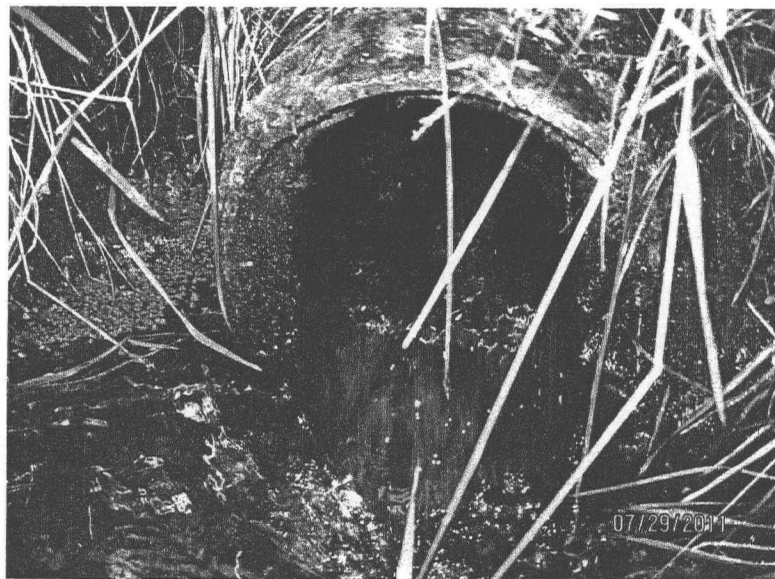
Inside Drain 11

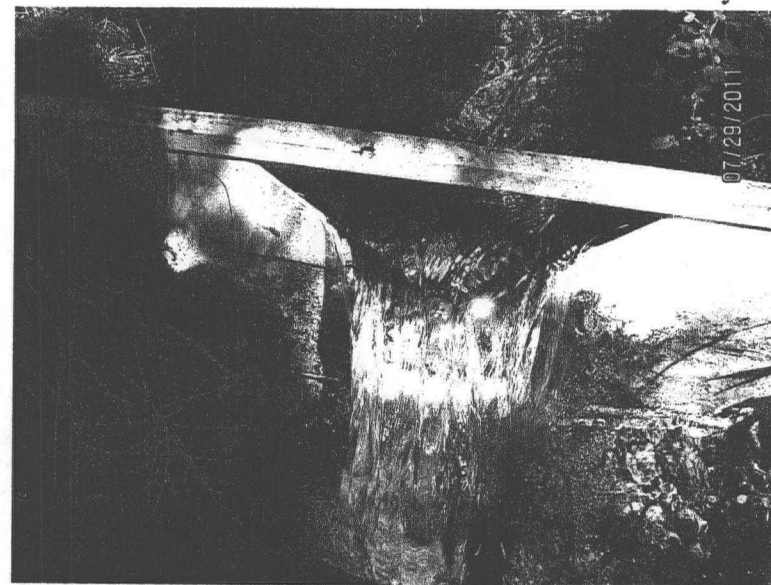
Drain 12

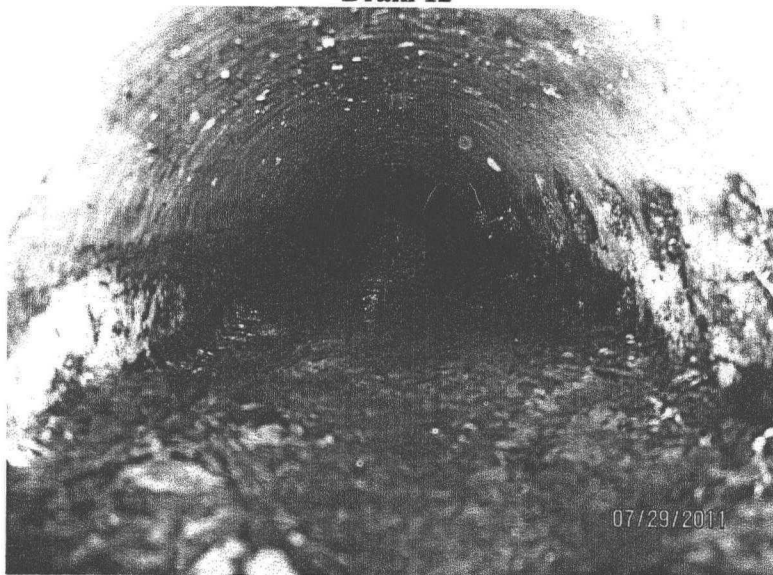
Weir 12 Flows

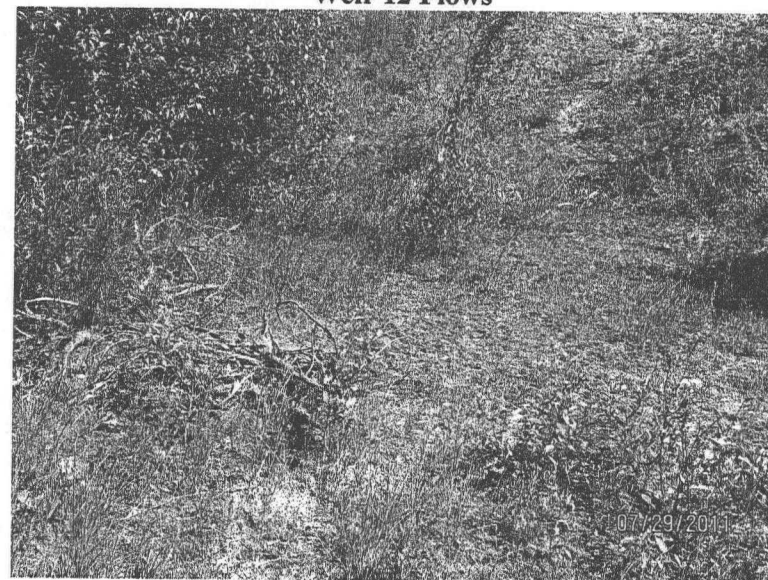
Inside Drain 12

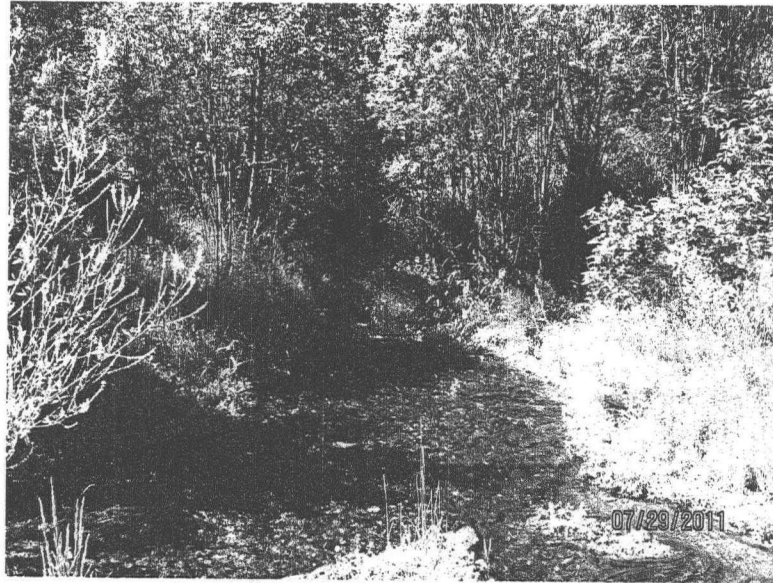
Previously Wet Area above Drain 12
